CUSTOMER SERVICE REPORT

Stowe Mtn. Resort

**Emergency Repair of Failed Output
Bearings & Gearbox Overhaul**

Dan Droegkamp

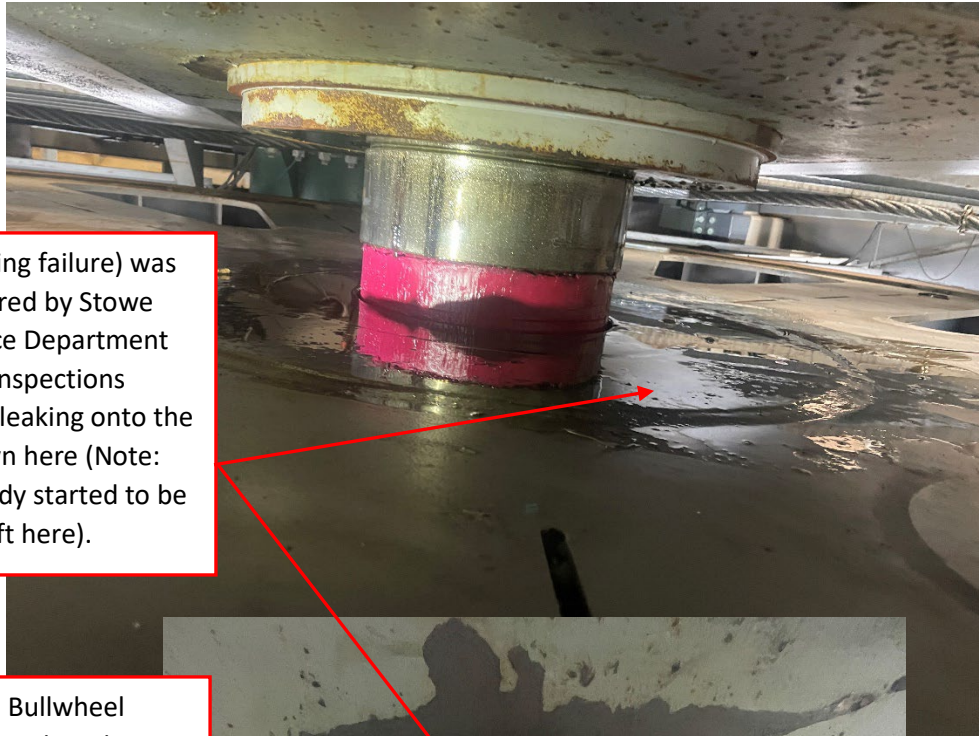
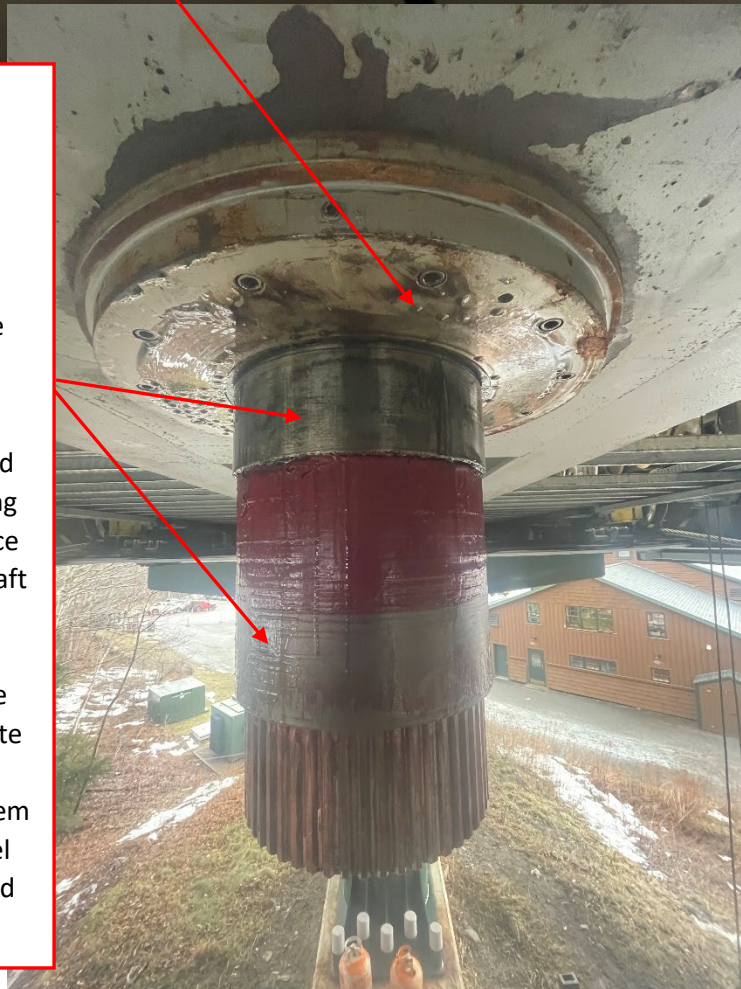
The issue (bearing failure) was initially discovered by Stowe Lift Maintenance Department during regular inspections noticing the oil leaking onto the bullwheel shown here (Note: bullwheel already started to be pressed off shaft here).

Also Note: The Bullwheel Bushings remained on the shaft during the Bullwheel removal. This should not happen, but the bushings were able to be removed intact, and reinstalled to the bullwheel.

- The Bushings were then fully cooled and measured confirming a proper interference fit to the Output Shaft of 0.002."
- The bushings were tack welded into the Bullwheel to facilitate future Bullwheel removal (to help them stay in the Bullwheel as they are supposed to).

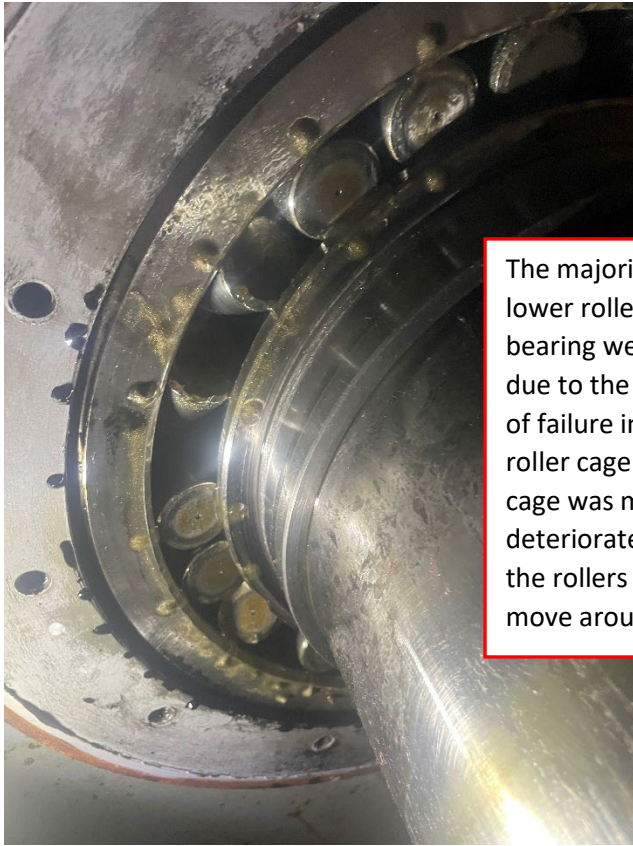
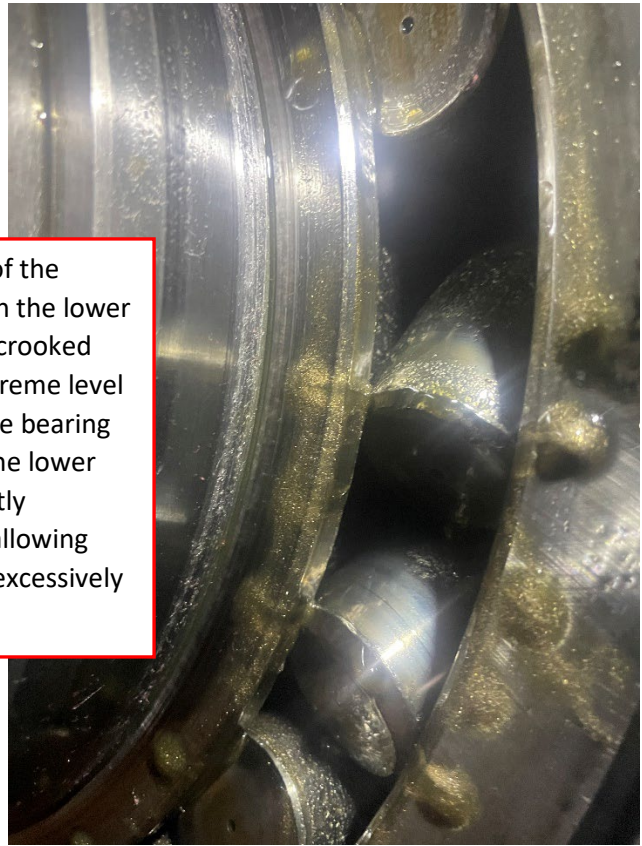
The majority of the lower rollers in the lower bearing were crooked due to the extreme level of failure in the bearing roller cage. The lower cage was mostly deteriorated allowing the rollers to excessively move around.

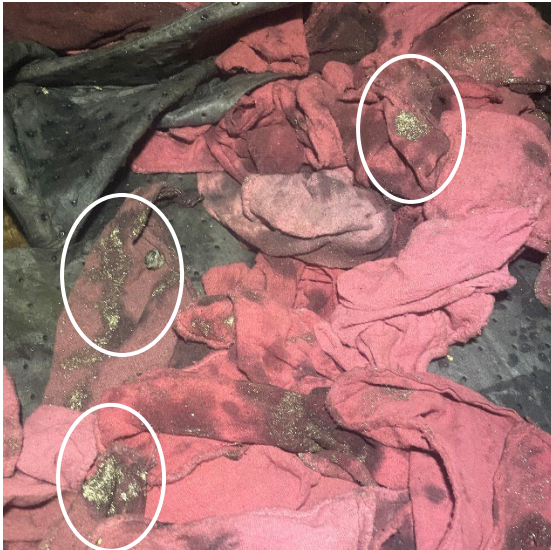
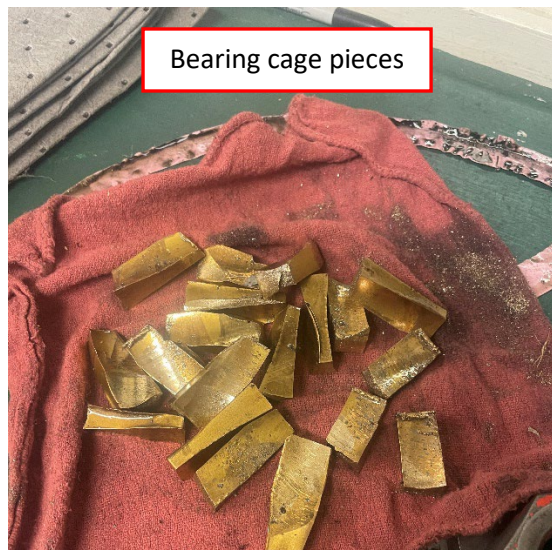
There were extremely high levels of contaminants found during disassembly.

- A lot of brass "glitter" from the output bearing roller cages breaking down
- Parts of the lower bearing cage that had worn completely off and were loose in the bearing exponentially breaking down adding to the contamination

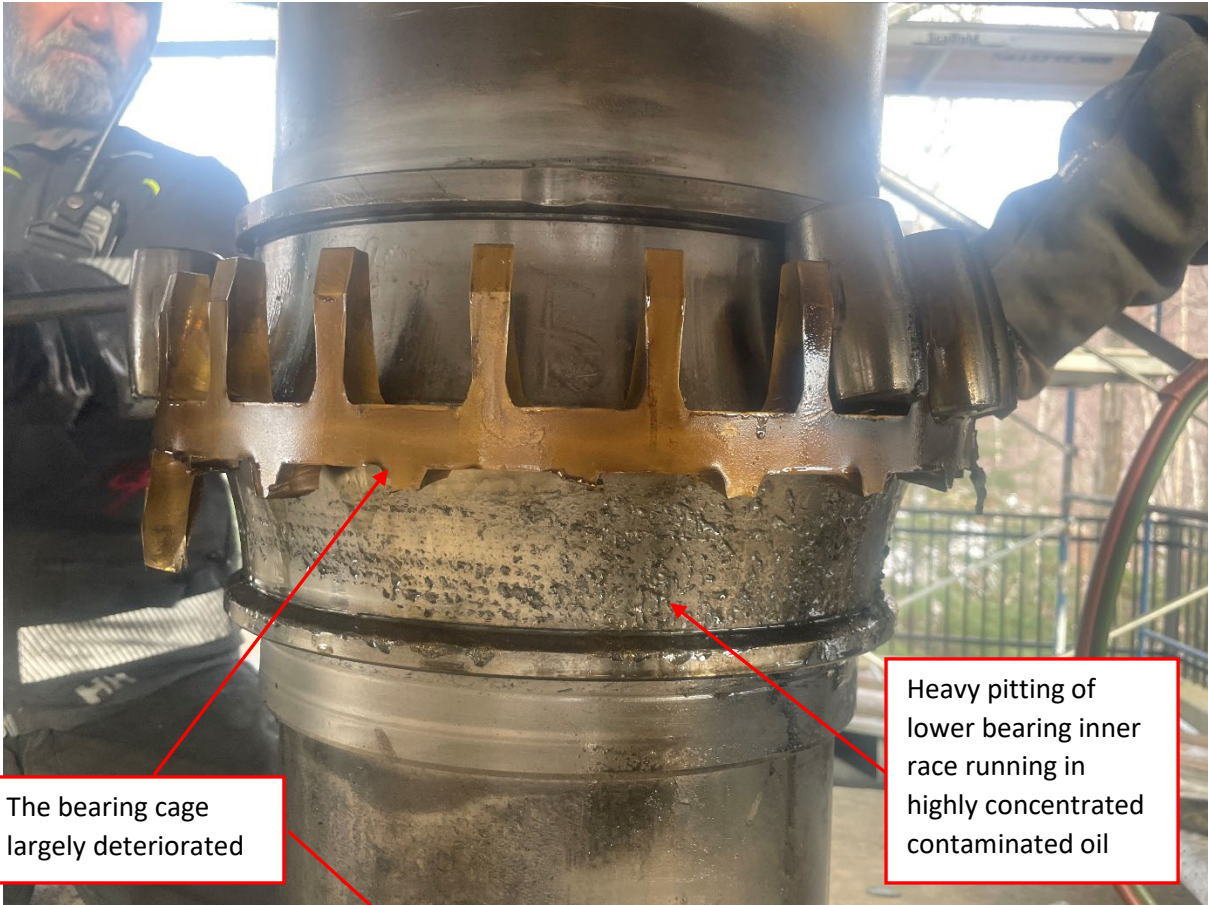
The bearing cage largely deteriorated

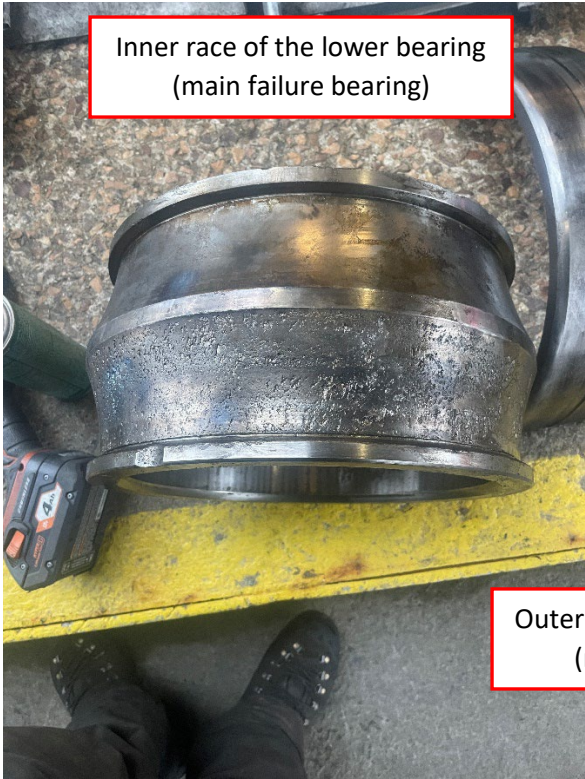
- One possible cause of the initial damage is foreign material got into the bearing and caused damage to the bearing, which resulted in increased wear during operations.

Inner race of the lower bearing
(main failure bearing)

Possible evidence of foreign debris
damage initiating bearing break-down
failure.
(significant indication noted at roller area)

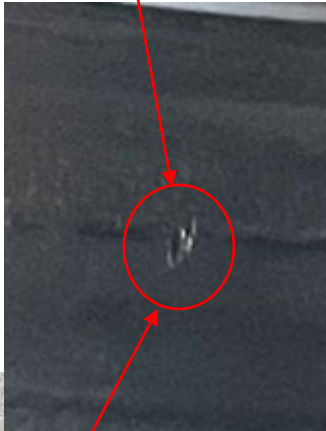
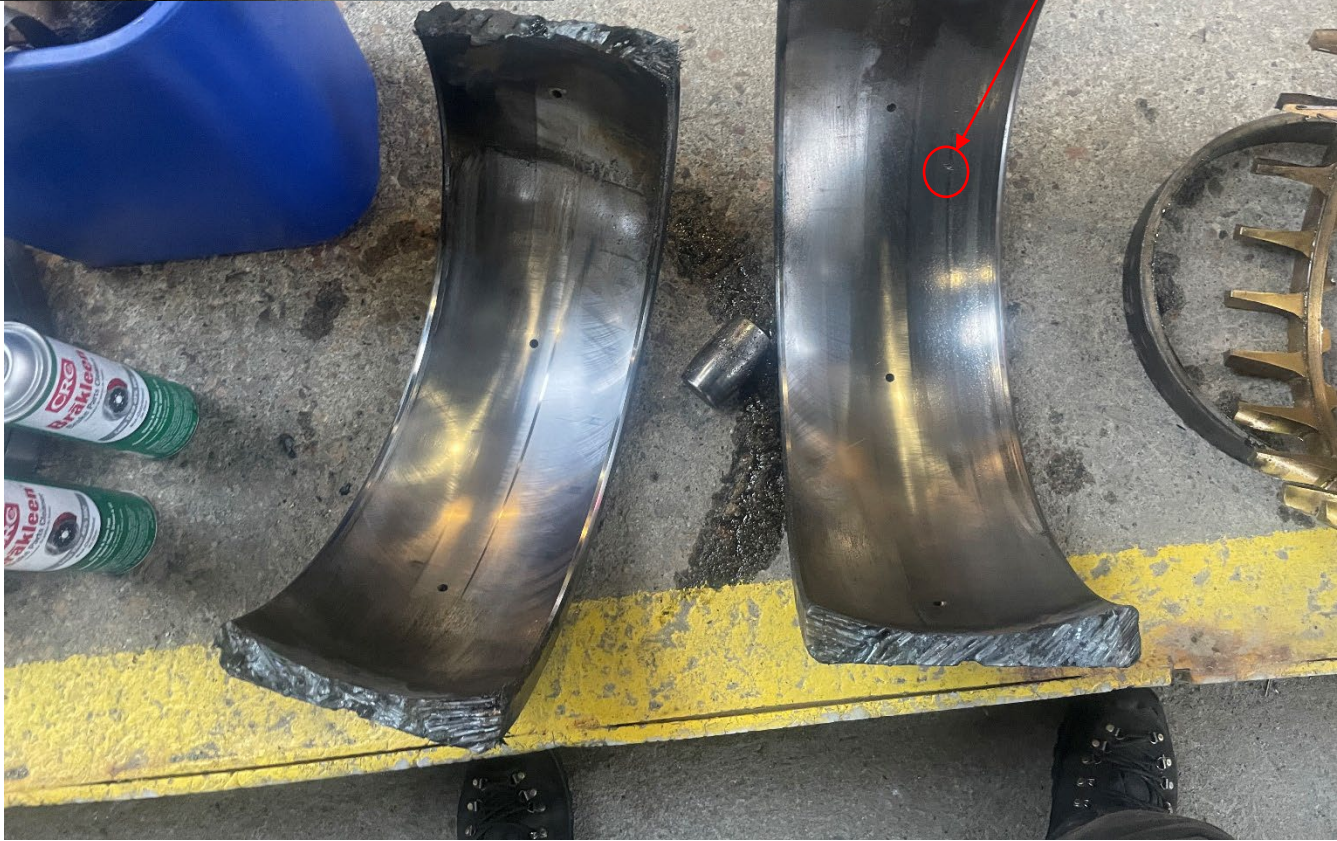
Outer race of the lower bearing
(main failure bearing)

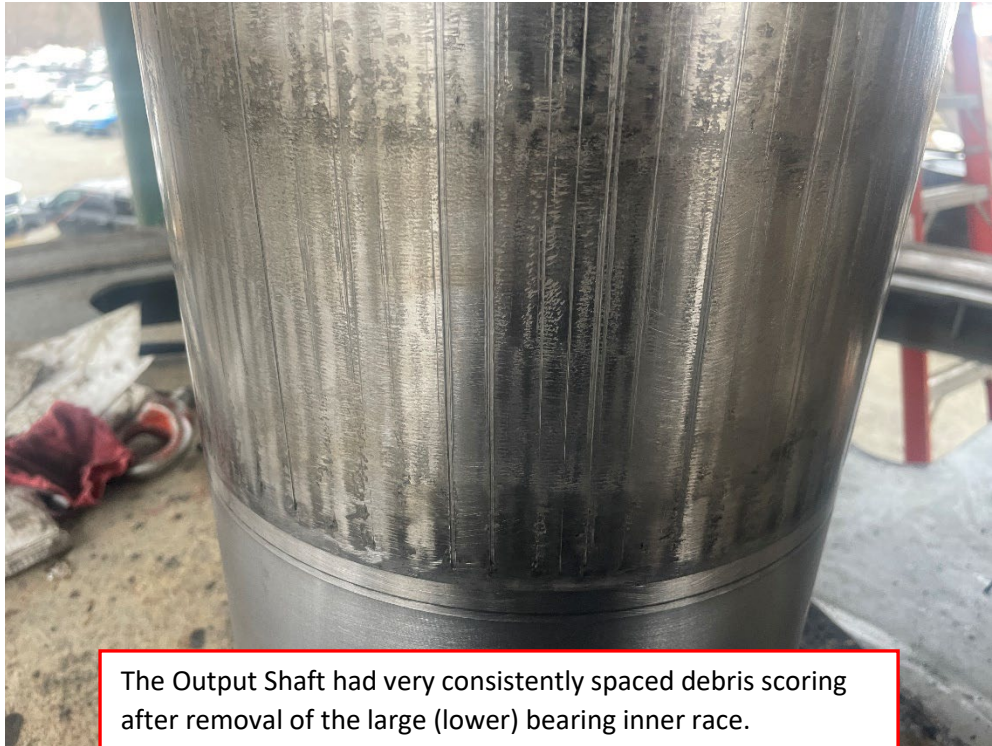
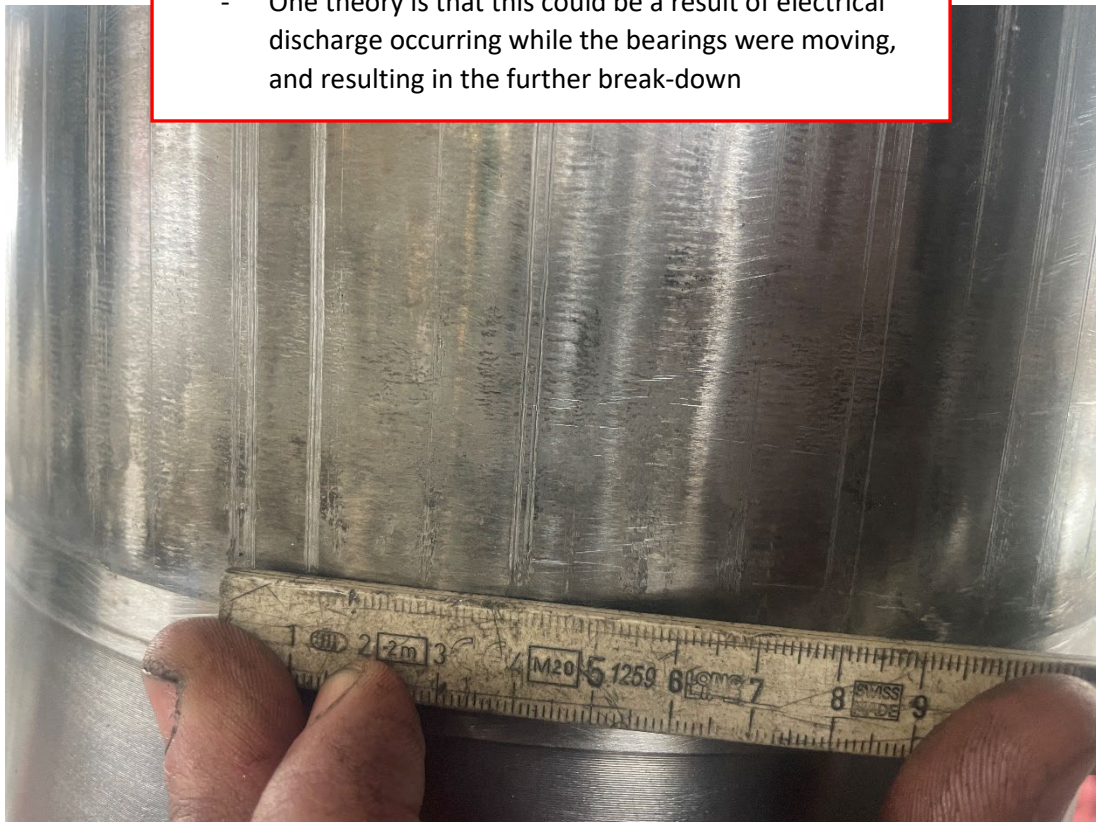
- Another possible cause of the initial damage is electrical arcing from a high-voltage ground fault. Either lightning or other source of high-voltage current passed through the bearings and arced causing damage eventually leading to the levels of bearing failure/break-down that was found upon disassembly.

The Output Shaft had very consistently spaced debris scoring after removal of the large (lower) bearing inner race.

- One theory is that this could be a result of electrical discharge occurring while the bearings were moving, and resulting in the further break-down

- Regardless, the electrical system within AND surrounding the ski lift drive should be thoroughly investigated for proper grounding throughout.
- See final page #15 for summary of all bearings changed during this emergency service work

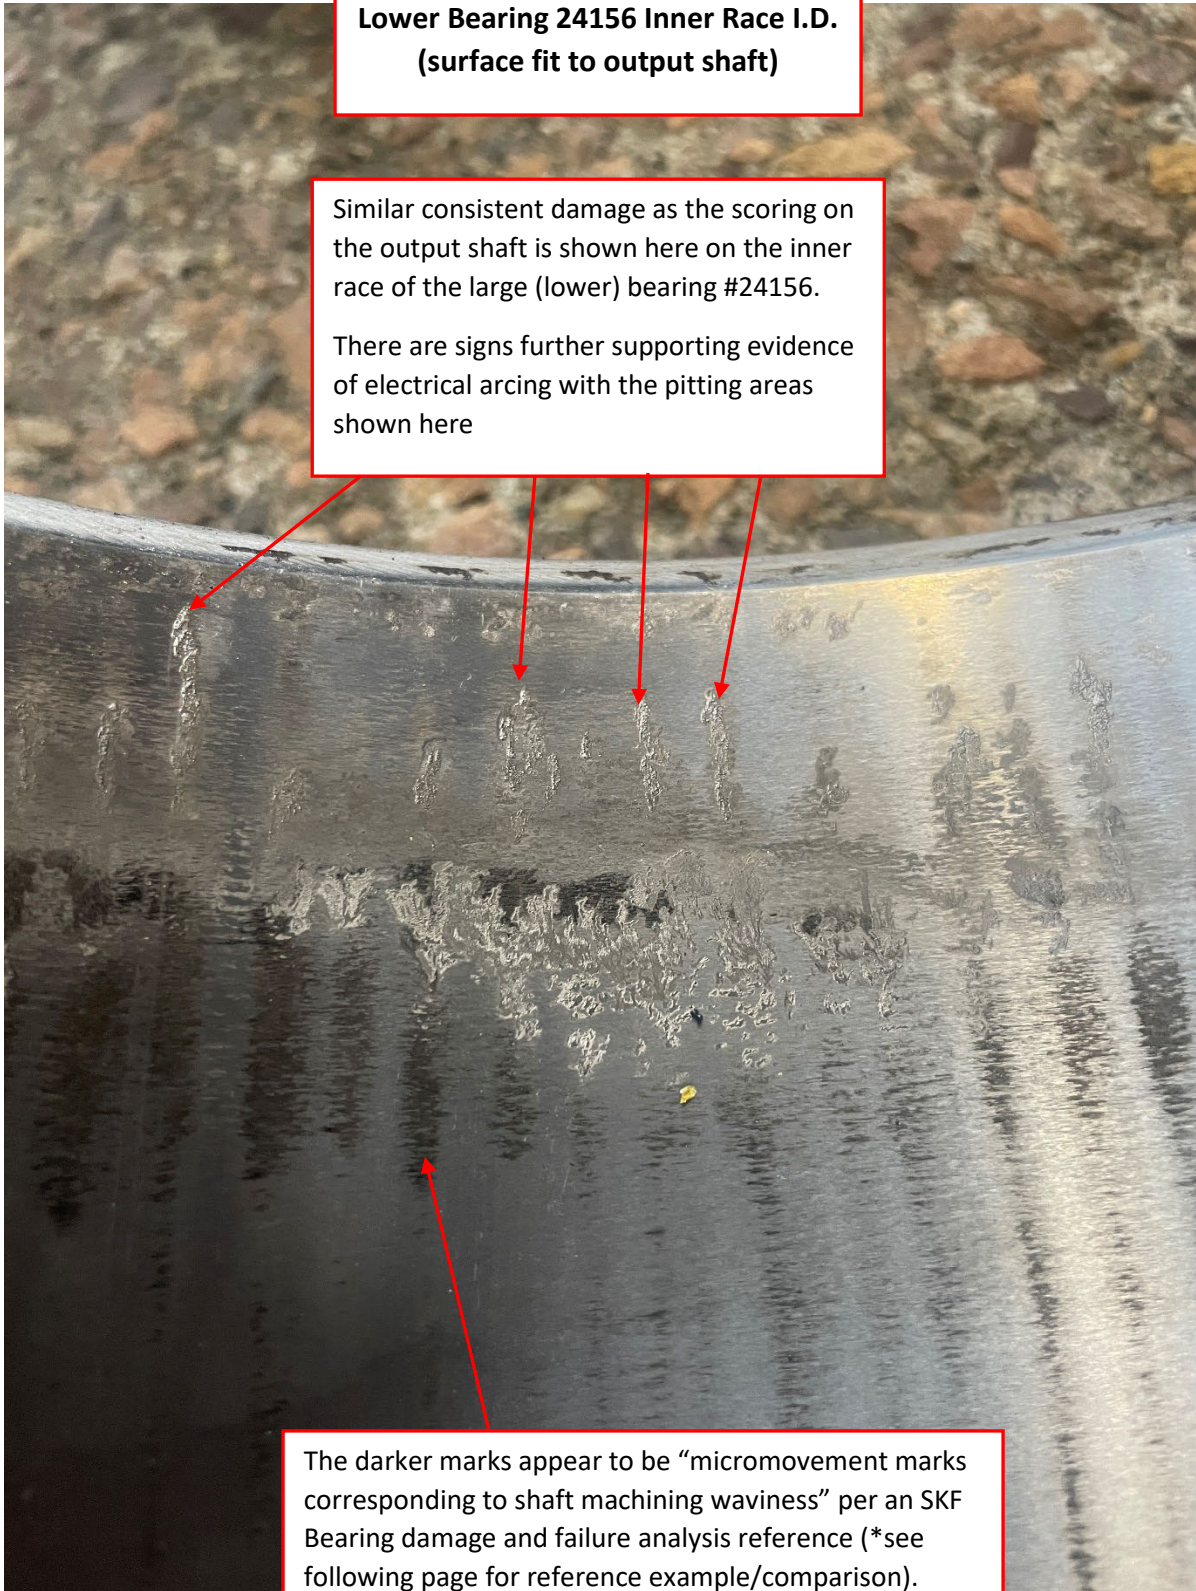
**Lower Bearing 24156 Inner Race I.D.
(surface fit to output shaft)**

Similar consistent damage as the scoring on the output shaft is shown here on the inner race of the large (lower) bearing #24156.

There are signs further supporting evidence of electrical arcing with the pitting areas shown here

The darker marks appear to be "micromovement marks corresponding to shaft machining waviness" per an SKF Bearing damage and failure analysis reference (*see following page for reference example/comparison).

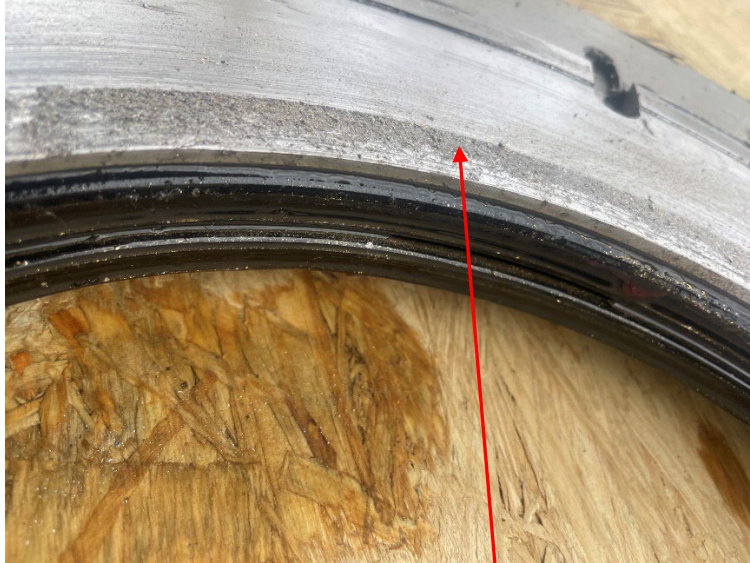
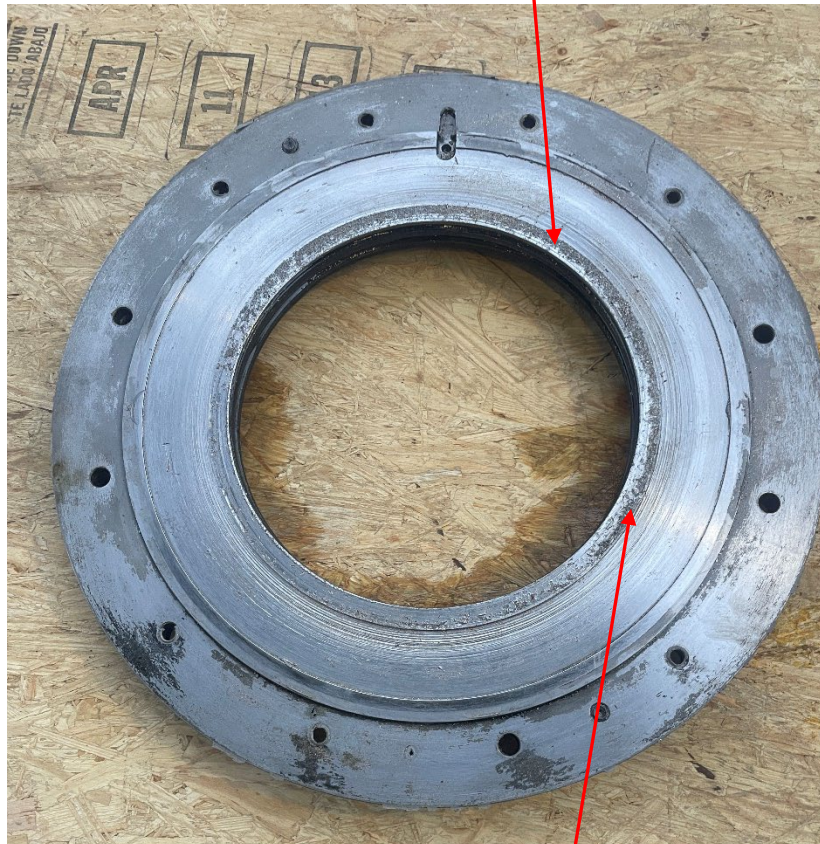
The Output Seal Plate was found to have cosmetic damage from all of the abrasive debris settling and running against the seal plate face shown here.

- This was cleaned up and is of no further concern.
- This abrasive debris is the direct reasoning that the output seals started to leak oil, as it damaged the seals.

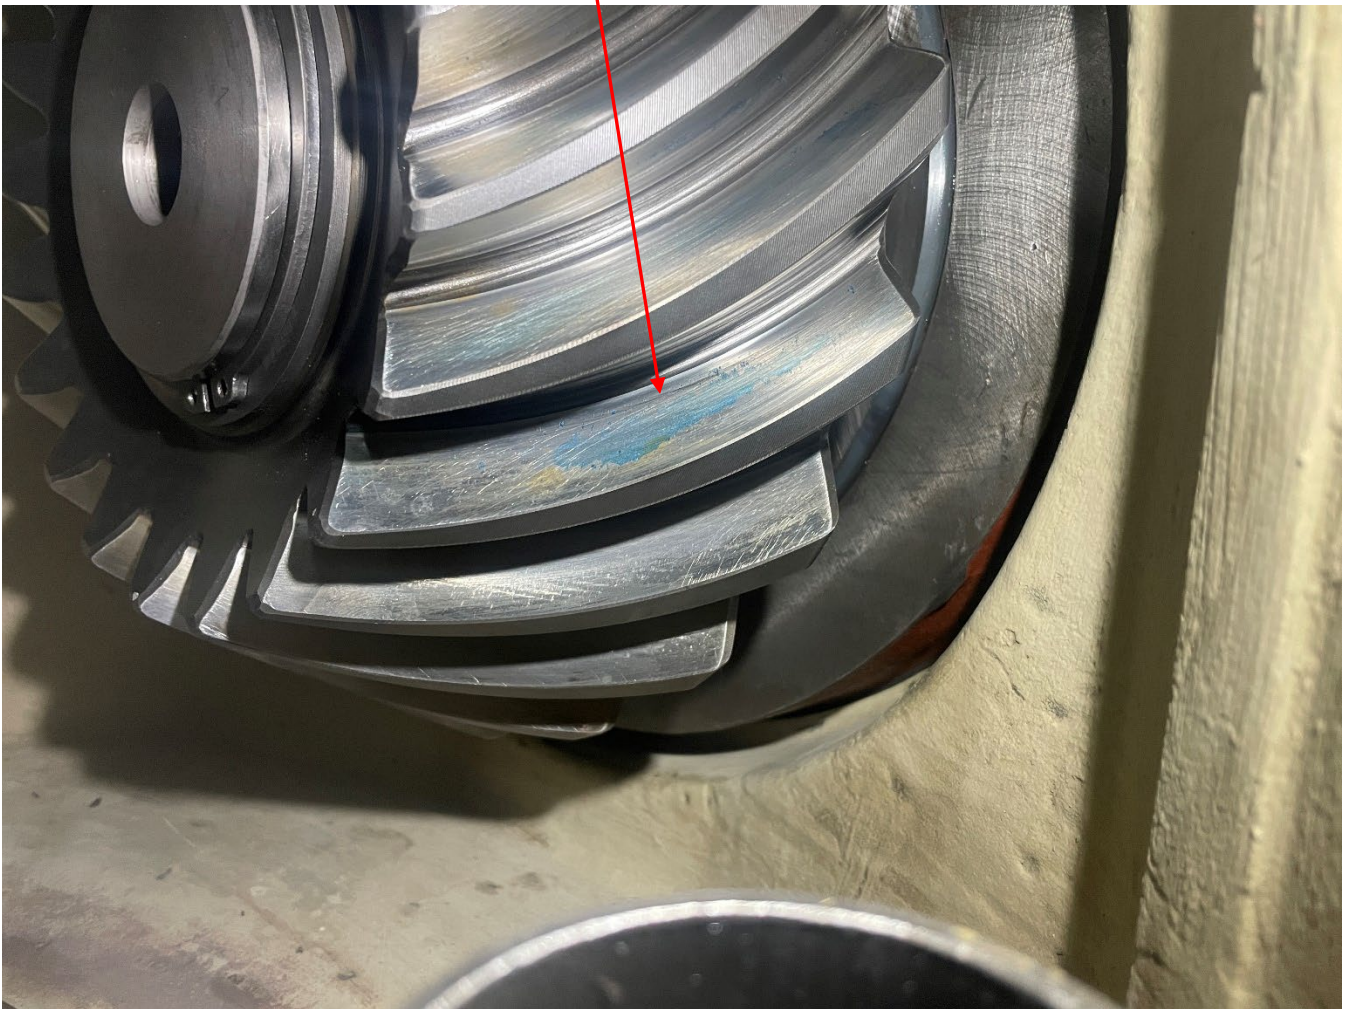
Shown here is the final high-speed gear contact pattern with a backlash of 0.30mm

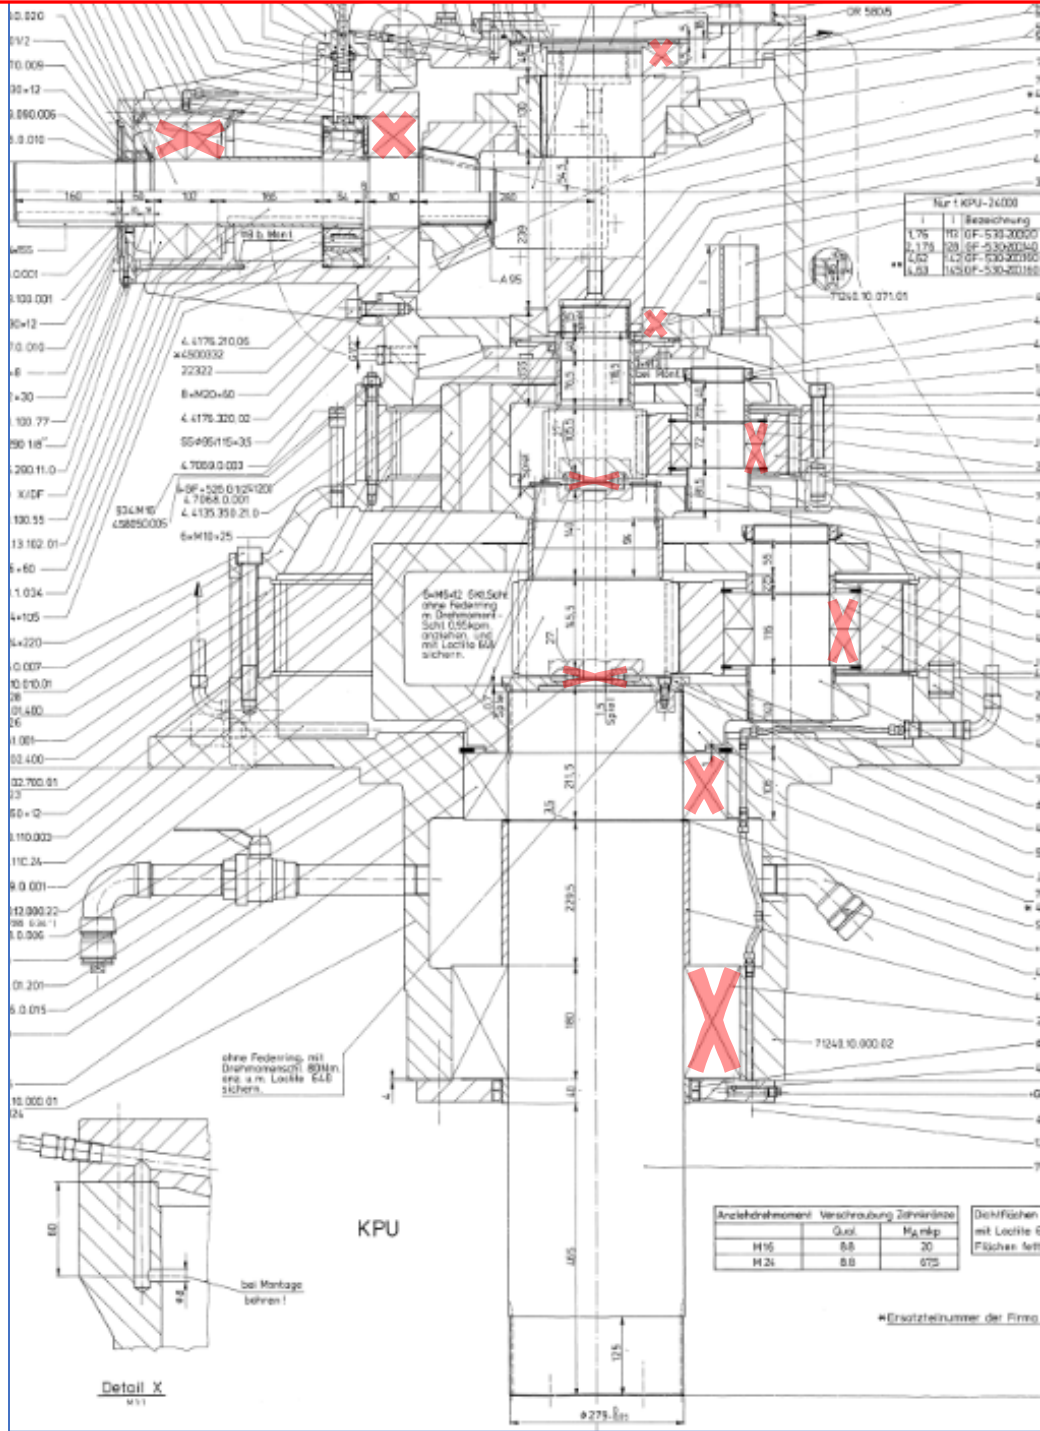
In Summary the Bearings Changed are Marked Below with a Red X
 (*also, related seals, bushings, etc. changed)
 (**The auxiliary bearings on either side were not changed. Just the main high-speed input components)
