CUSTOMER SERVICE REPORT

Report prepared for:
Mount Sunapee

Project/Quote #:
21-014

Project Description:
**Clipper Ship Quad
Gearbox Overhaul**

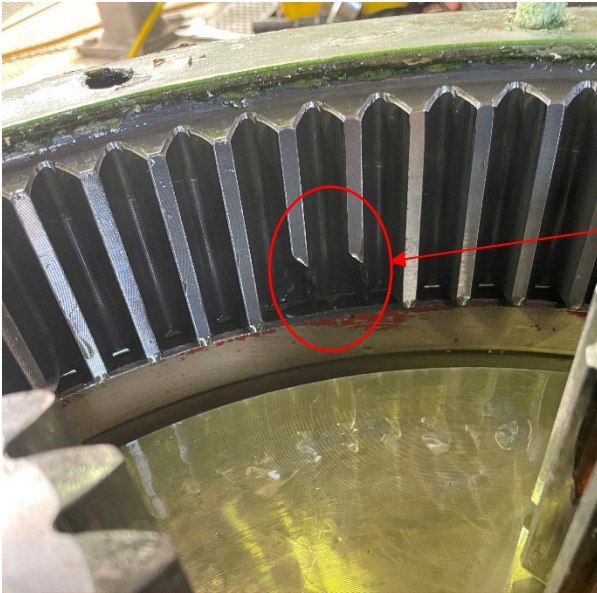
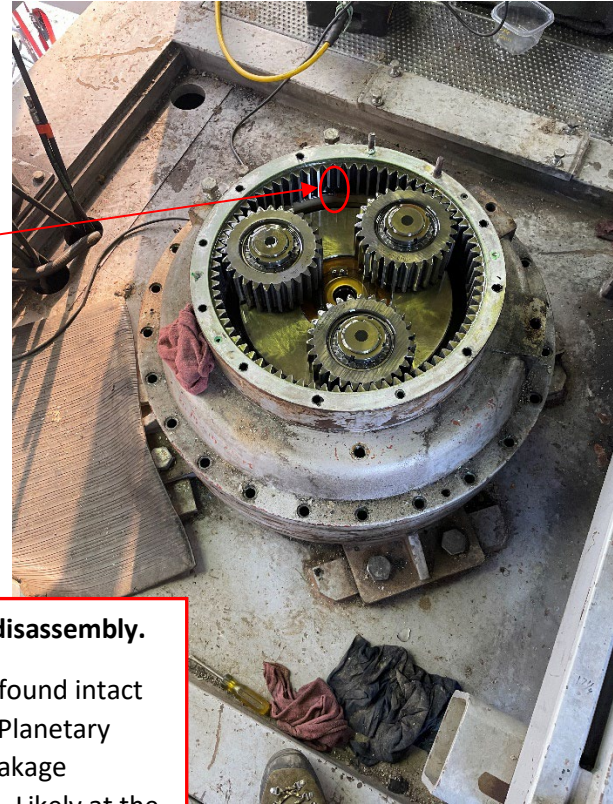
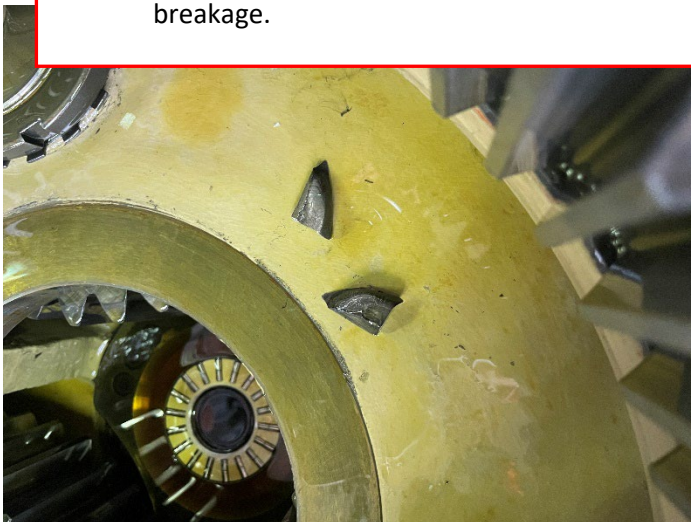
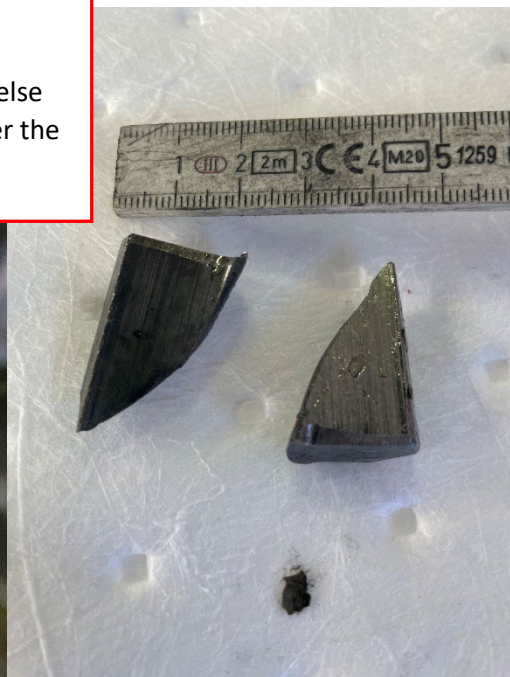
- Upon disassembly the 2nd Stage Ring Gear was found to have multiple broken gear teeth (pictures included in following).
 - This Ring Gear was replaced with new sourced and supplied from the OEM Kissling of Switzerland

2nd Stage Ring Gear damage found during disassembly.

- The pieces of the broken teeth were found intact laying on top of the lower (1st Stage) Planetary housing indicating that the tooth breakage happened recently during operations. Likely at the very end of summer operations...
- The broken pieces did not show any signs of further damage to themselves, or anywhere else throughout the gearbox from operations after the breakage.

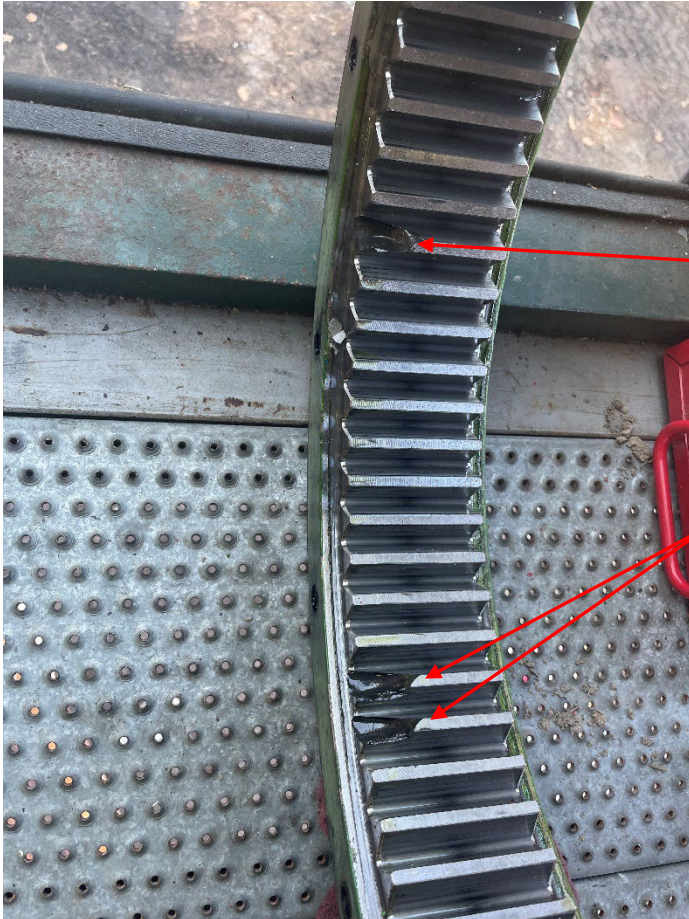
Three teeth total were found broken during disassembly on the 2nd Stage Ring Gear

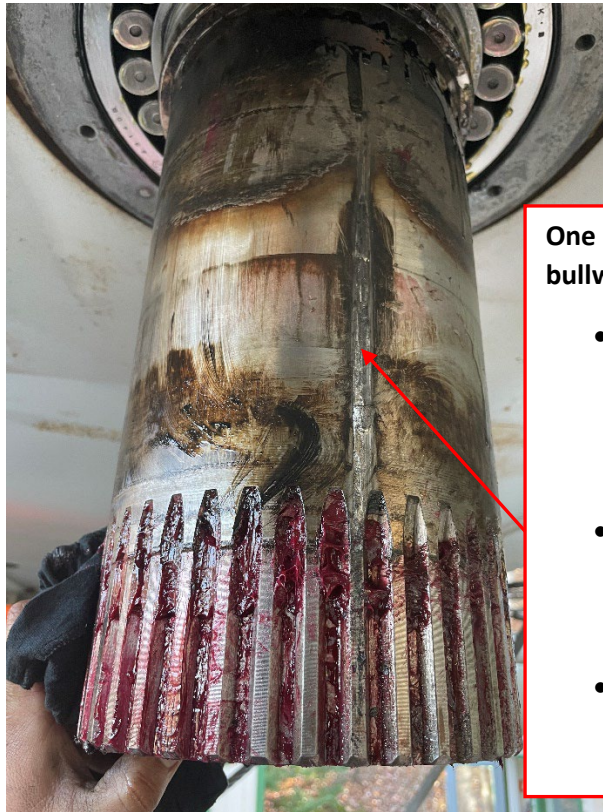
- It was stated that when the lift was built the bullwheel hub did not have grease zerks installed from the factory, so these were drilled and installed after initial assembly in the field. This created metallic debris inside the bullwheel hub cavity, and therefor inevitably created minor damage when removing the bullwheel for the first time since construction assembly.

One burr damage created upon bullwheel removal.

- This is from internal debris (metallic) due to the drilling installation of the two grease zerks needed after initial assembly/construction.
- This was thoroughly cleaned up with a die grinder, and the reassembly went smoothly all the way.
- This is of no major concern for continued use.

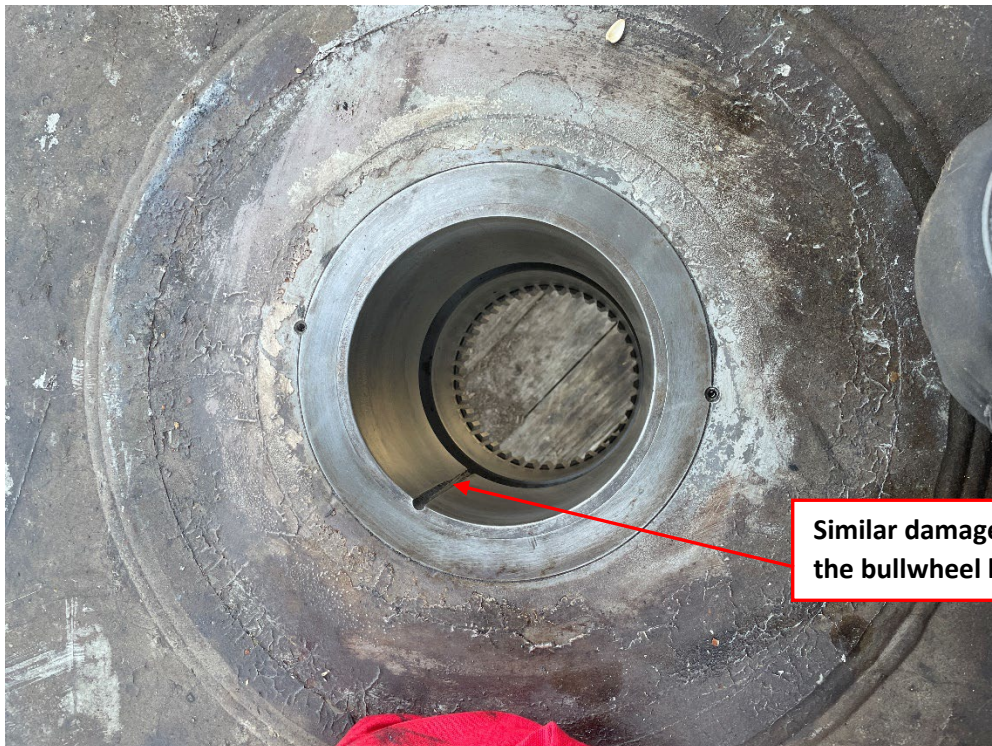
Similar damage mirrored in the bullwheel bushings.

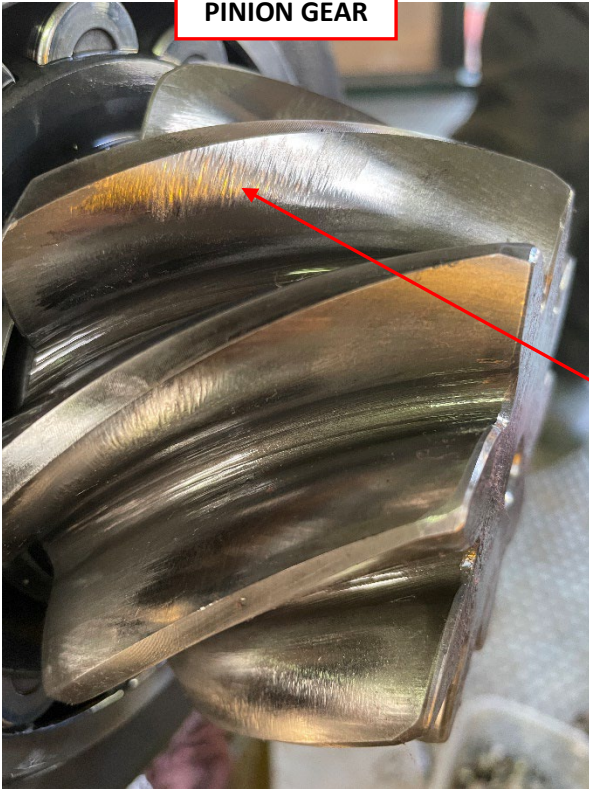
PINION GEAR

Damage to the original Bevel/Pinion Gear Set from worn/bad gear contact pattern and backlash setting.

- This created the bad vibrations felt and heard throughout the drive terminal during operations.
- There should not be this amount of scoring wear on these gear teeth. These gears are hardened and should always be very smooth.
- Continued operations would indefinitely result in further damages once these gears reached a failure state of wear.
- These gears were known to be worn beyond acceptable and were replaced with new.

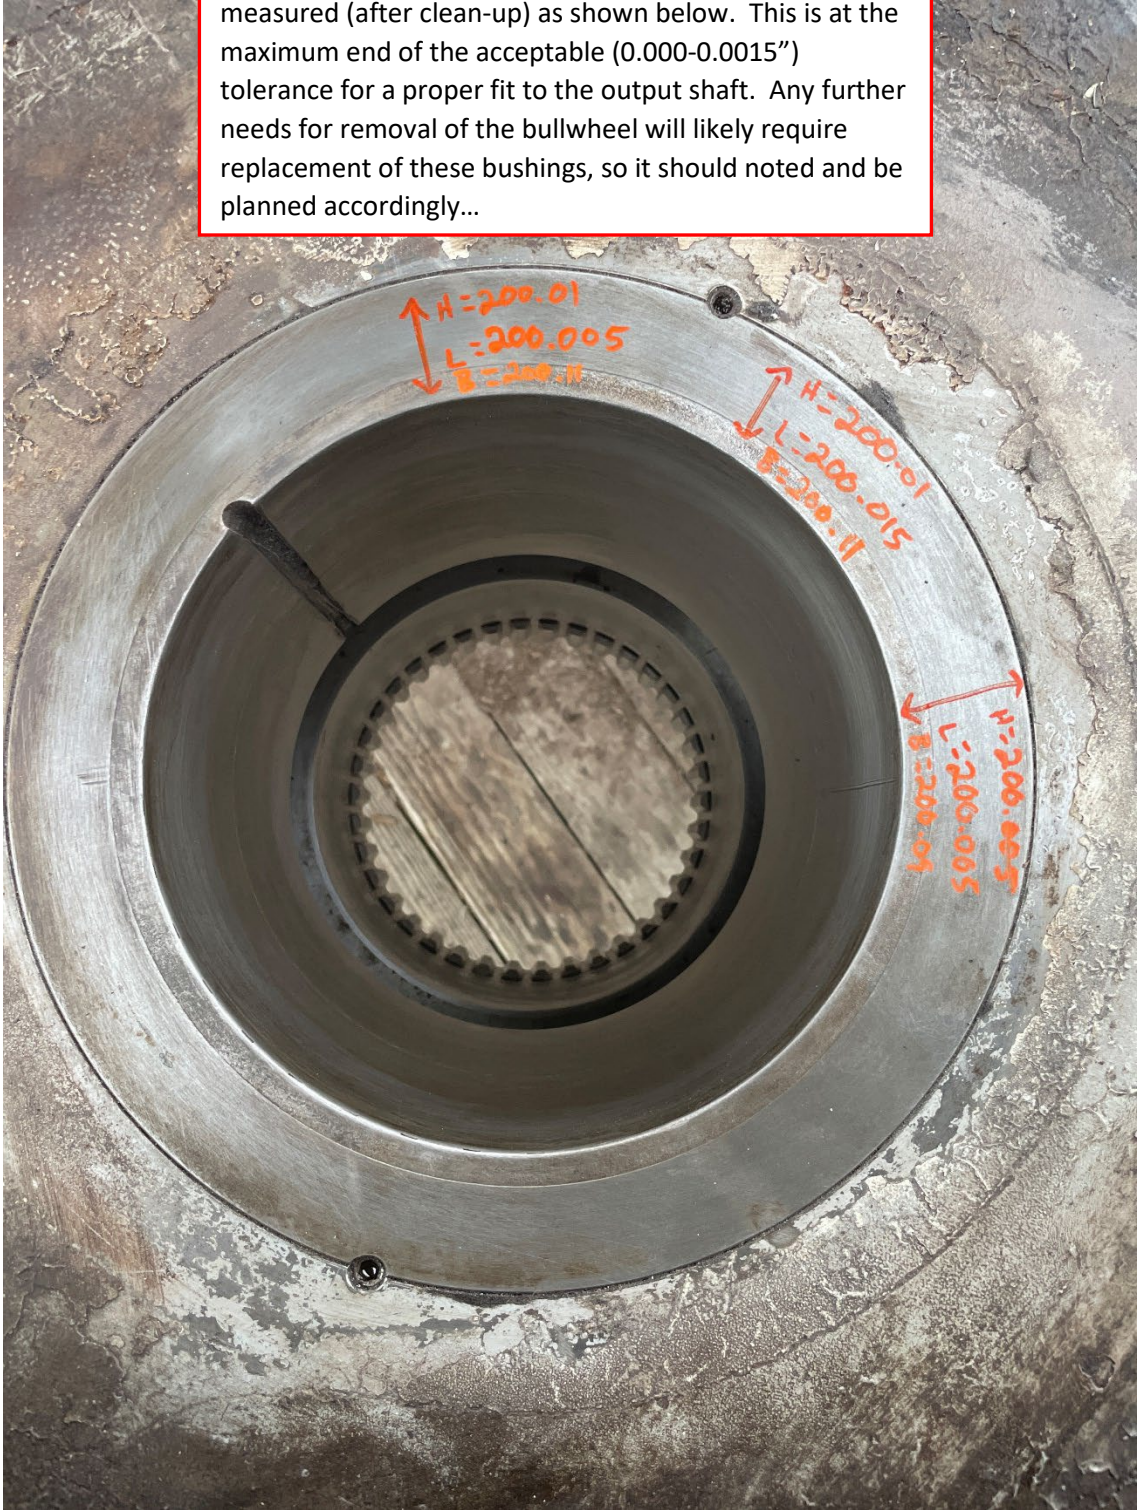
At an upper tolerance for the bullwheel bushings measured (after clean-up) as shown below. This is at the maximum end of the acceptable (0.000-0.0015") tolerance for a proper fit to the output shaft. Any further needs for removal of the bullwheel will likely require replacement of these bushings, so it should be noted and be planned accordingly...

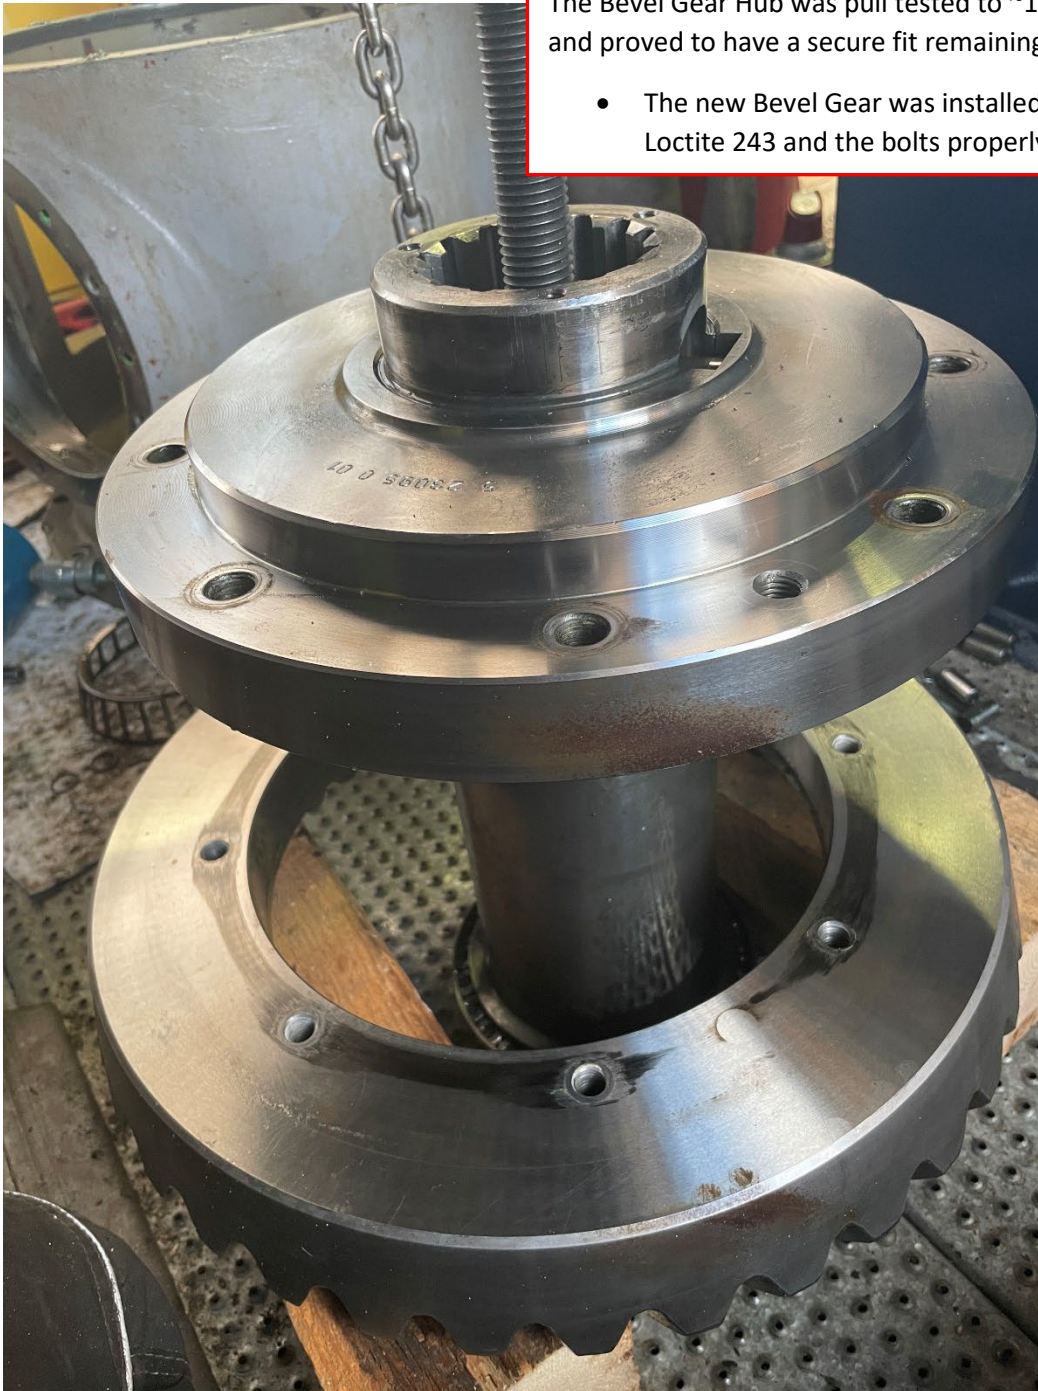
The Bevel Gear Hub was pull tested to ~13 tons and proved to have a secure fit remaining.

- The new Bevel Gear was installed with Loctite 243 and the bolts properly torqued
