CUSTOMER SERVICE REPORT

Stowe Mtn. Resort

**Emergency Repair of Failed Output
Bearings & Gearbox Overhaul**

Dan Droegkamp

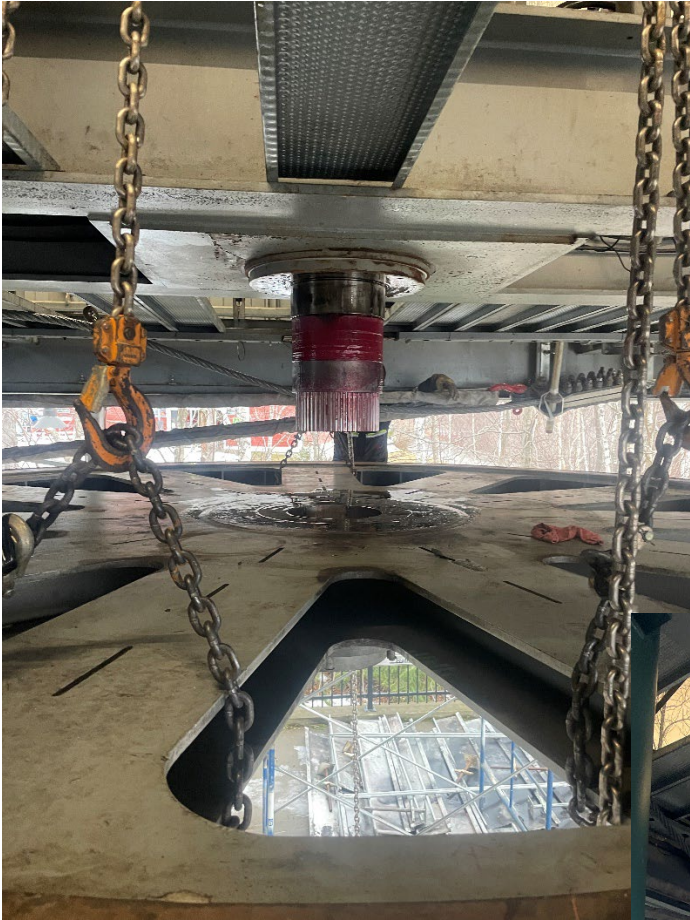
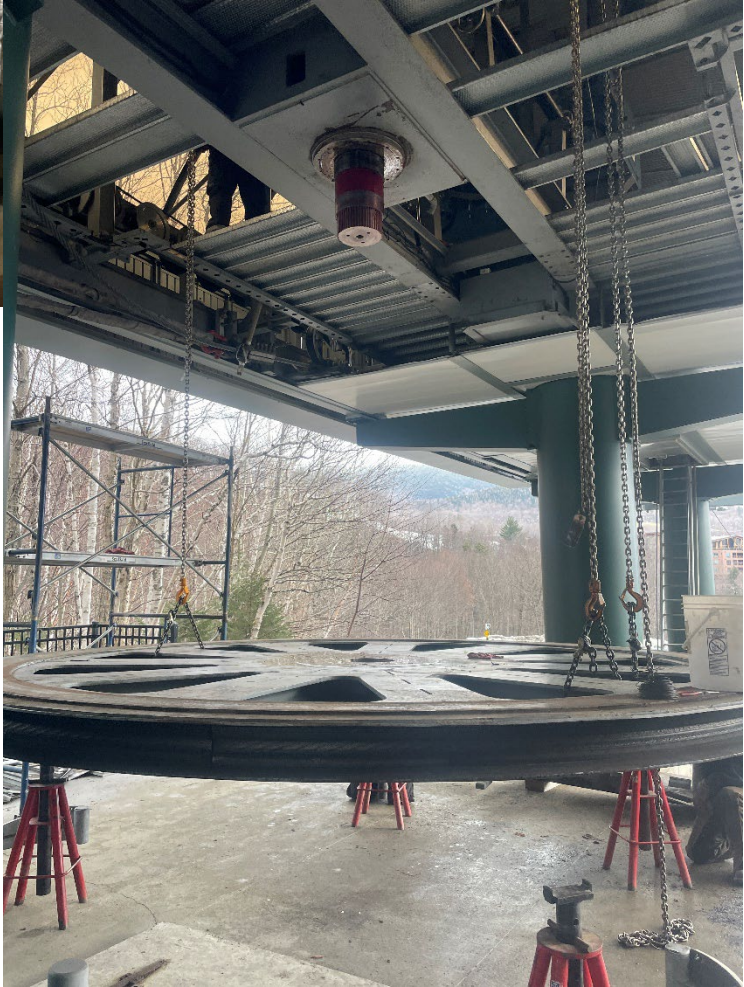
The majority of the lower rollers in the lower bearing were crooked due to the extreme level of failure in the bearing roller cage. The lower cage was mostly deteriorated allowing the rollers to excessively move around.

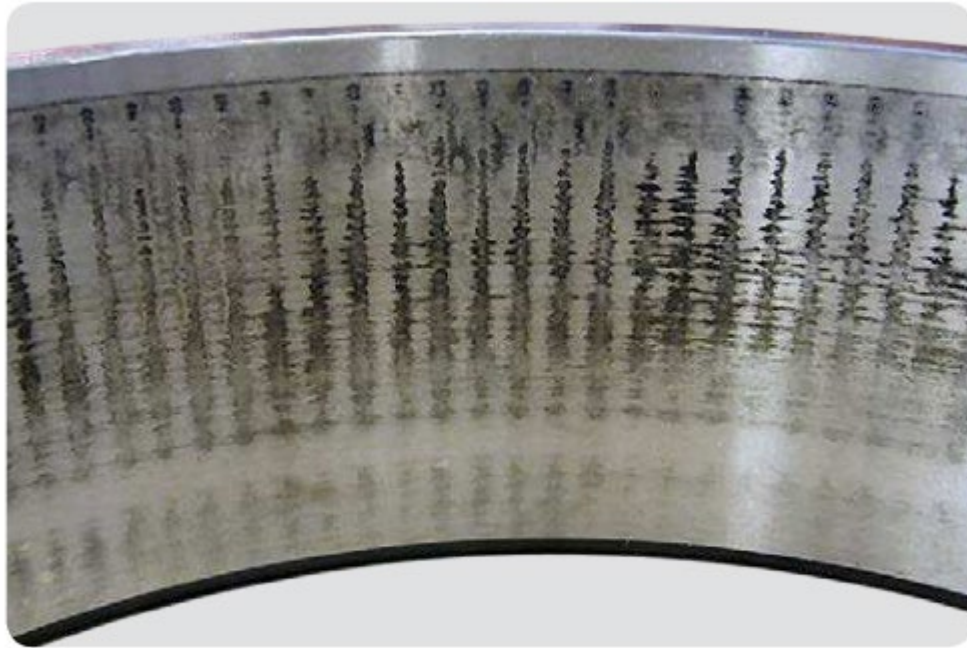
*Tapered roller bearing inner ring
Micromovement marks corresponding to shaft machining waviness*
